Restoring Historic Terra Cotta

OLGA A. VAYSMAN

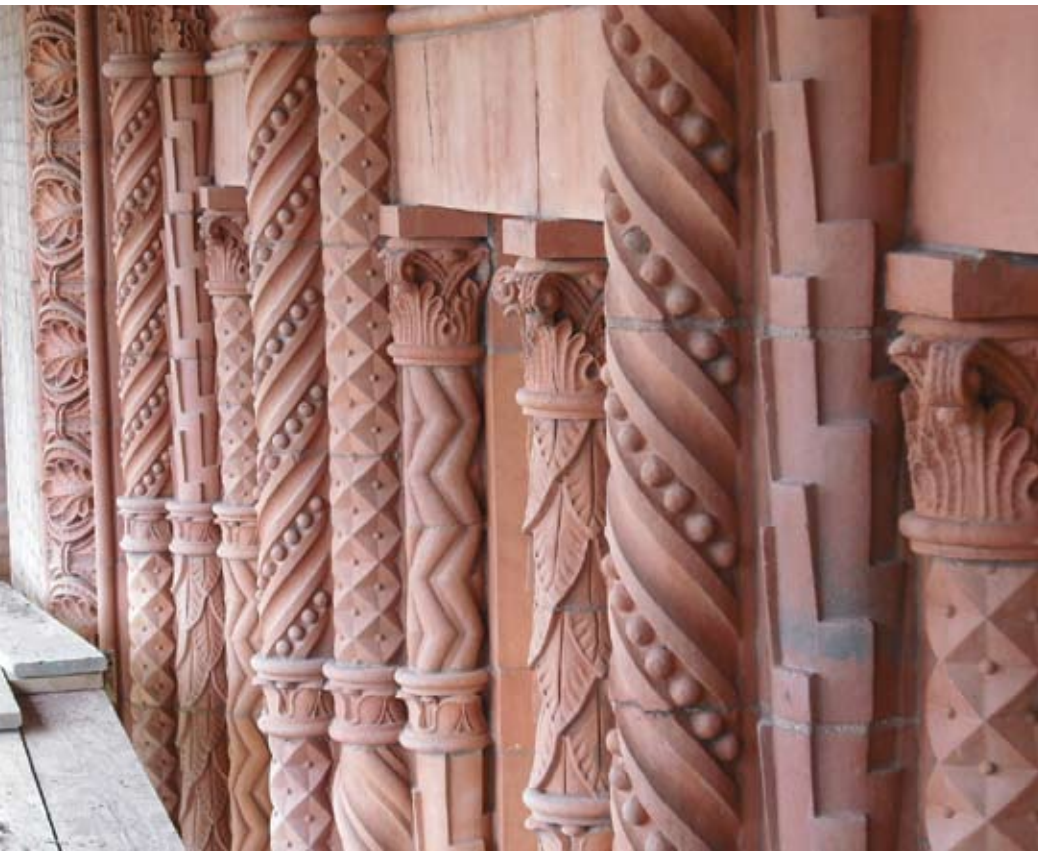
Photo: Series of terra cotta columns.

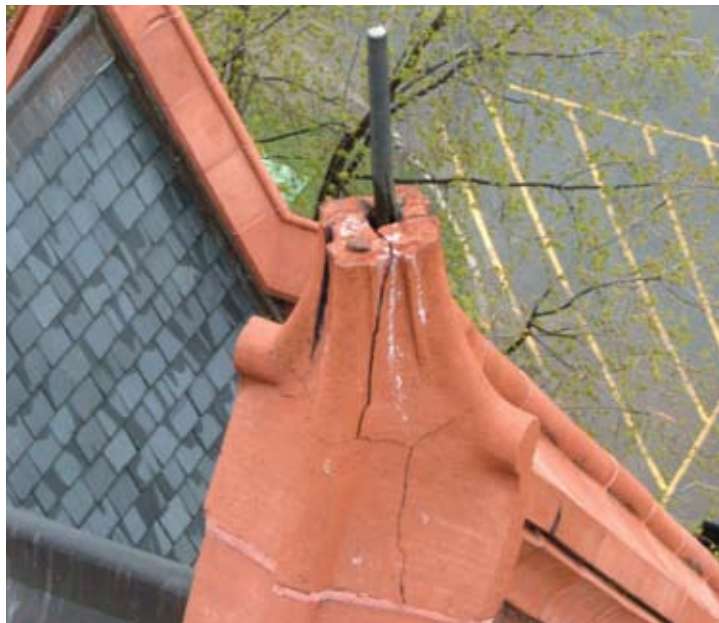
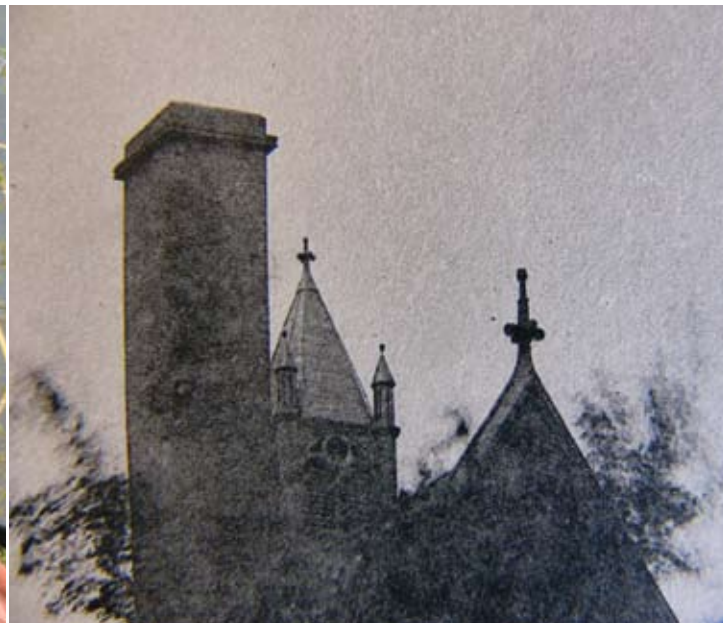
Photo: The photo of the current condition (on left) shows the missing finial and cracked base. Historic photos (such as the one on the right) allowed us to see the original profile of the finial so that it could be accurately replicated.
